F-8-125
Samuel Nusbaum Farmstead

Survey No. F-8-125
Samuel Nusbaum Farmstead
Libertytown, Maryland vicinity
Frederick County, Maryland

State Historic Sites Inventory Form

7.1 Description

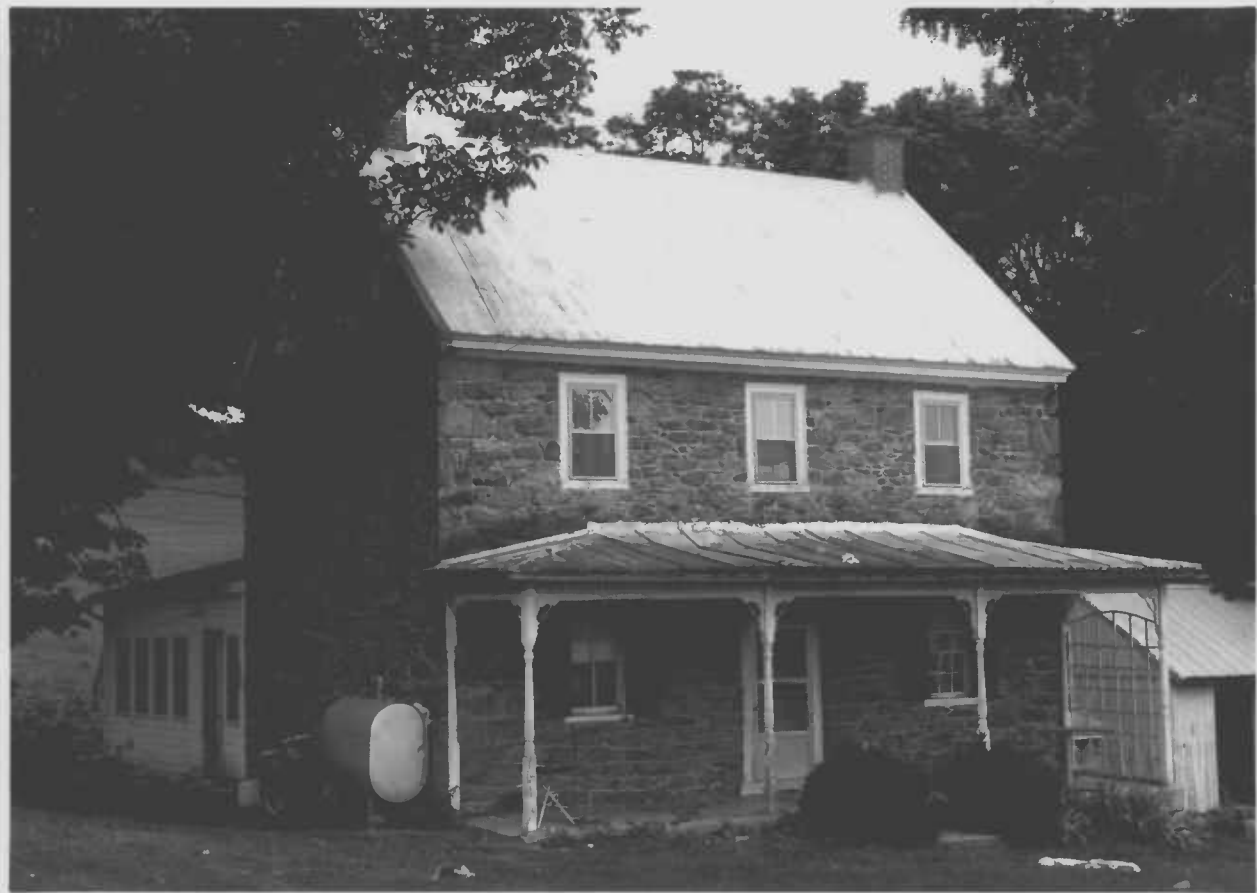
1/7

The dwelling is a two-story rubble stone building facing south. Its three-bay main elevation has a center entrance flanked by 6/9 and 6/2 windows. The second story windows are 2/2. The porch has turned columns with a dentil cornice frieze and turned spindle brackets. The door and window surrounds are plain. The door is a modern replacement with a glazed center panel and four light transom. The house has interior end chimneys and a corrugated metal gable roof. The east and west elevations of the main section have no opening, except square 2/2 attic windows and a concrete block bulkhead cellar entrance on the east elevation.

Neg. loc.: Md. SHPO, Crownsville, Md.
South elevation

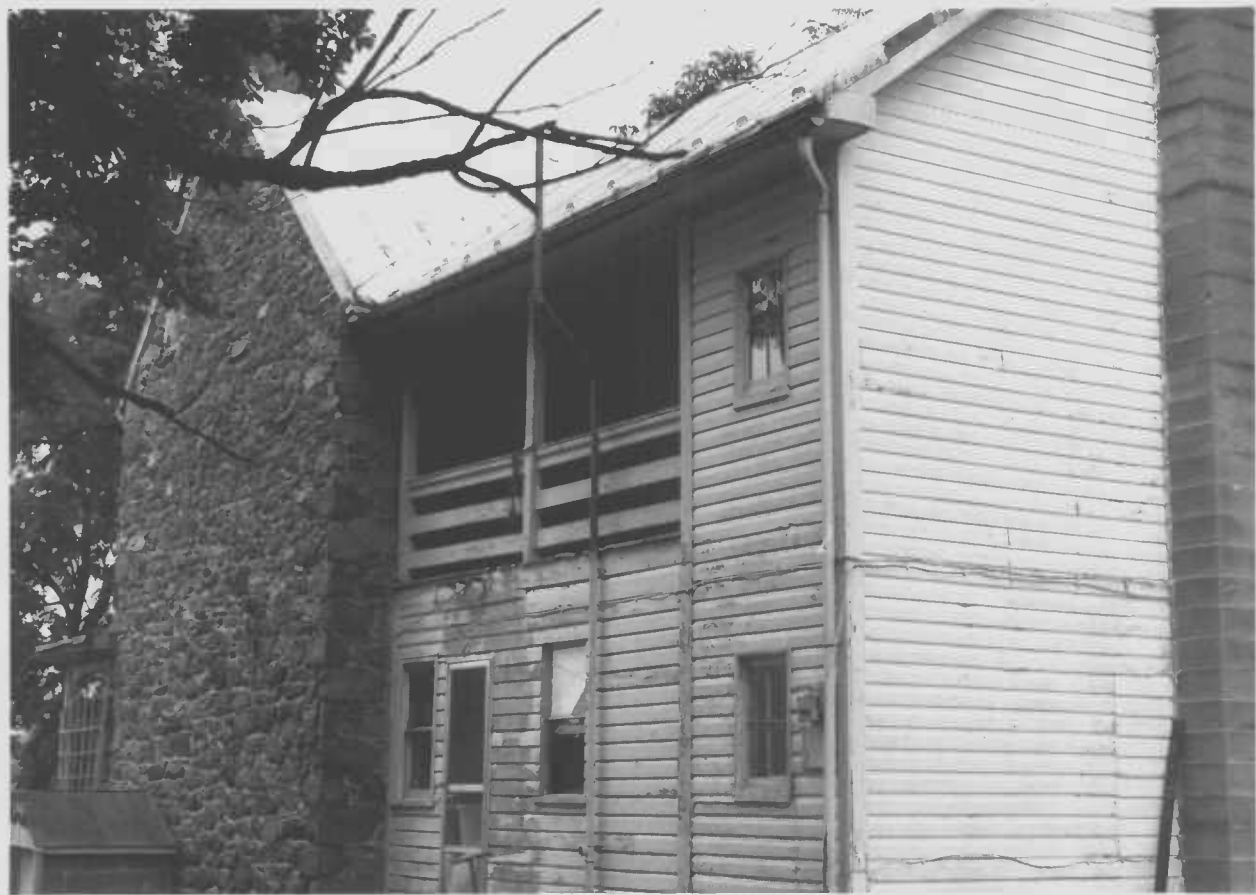
2/7

The ell extends northward from the northwest corner of the main section. It is also of stone construction and has a two-story porch on the east elevation with an enclosed lower level. The enclosure is faced with german siding, indicating the enclosure may have taken place in the last quarter of the 19th century. The second story level of the porch is open. The west elevation of the ell has a one-story enclosed porch.

North east corner view

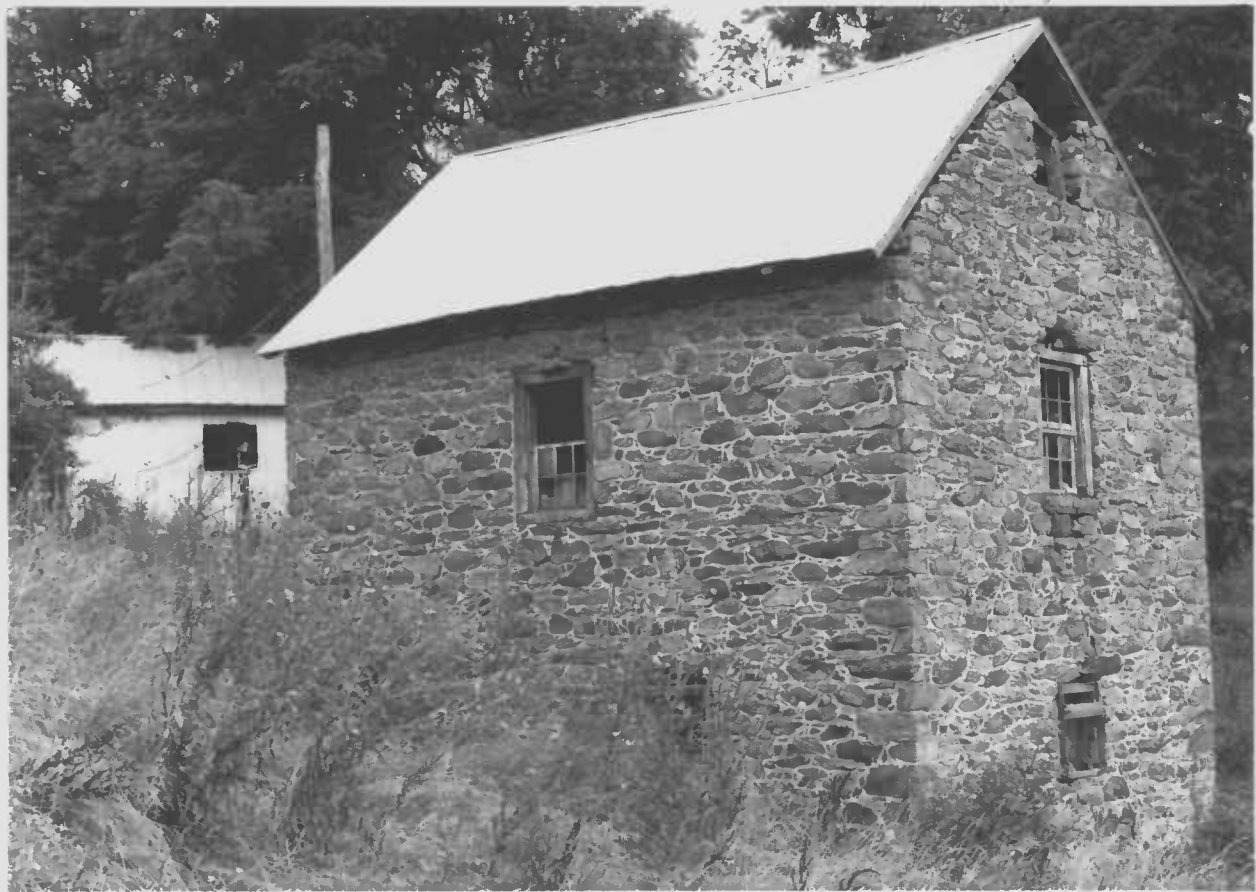
3/7

Springhouse: This two-level springhouse may be contemporary with the dwelling. It is located southeast of the house with its rectangular plan at a diagonal to the plane of the house. It has a standing seam gable roof and a single door in the northwest elevation. In the west elevation is a partial 6/6 sash window. Along the lower level of the springhouse are a series of barred openings although the bars are missing. Single deteriorated window openings are on both levels in the southeast elevation. The southeast gable peak is deteriorated.

Springhouse, south elevation

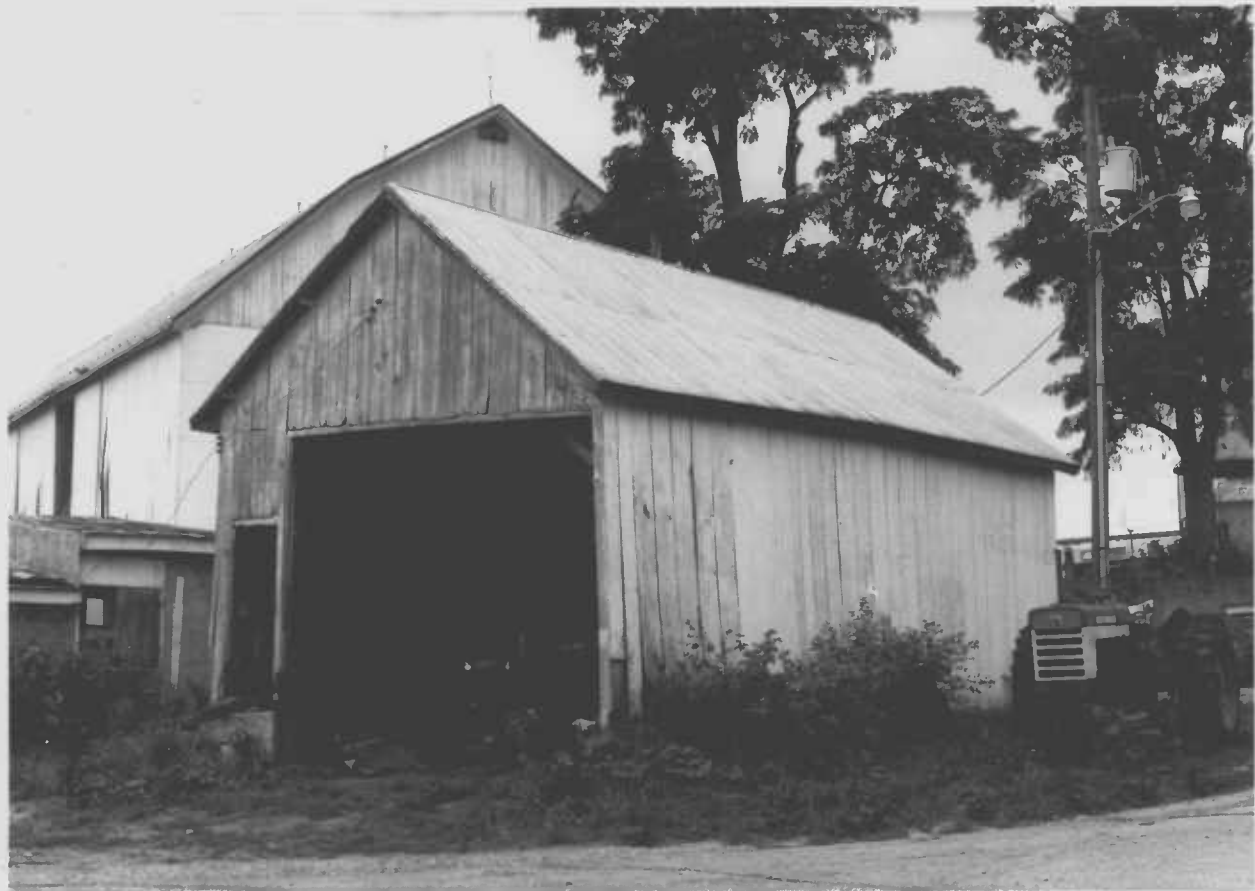
5/7

Corncrib/wagon shed: North of the barn is a circa 1875 frame corn crib/wagon shed with a single granary. The gable roof is corrugated metal. The siding is vertical flush boards.

Corn crib/wagon shed, north elevation

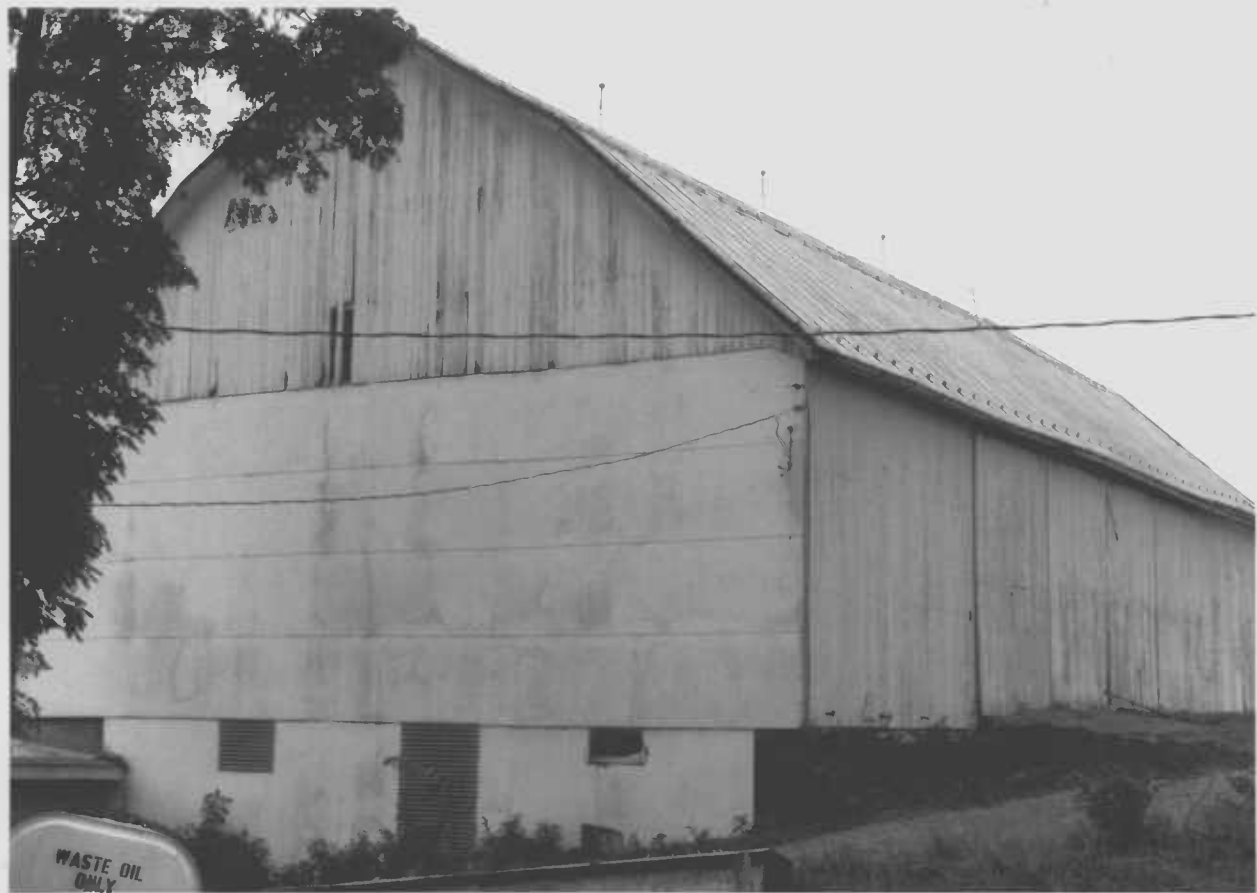
6/7

Bank barn: This circa 1875 frame barn is located southwest of the dwelling house in the center of the agricultural grouping. Sited at an angle with its drive floor entrance on the northwest, the barn has a partially enclosed forebay on the southeast elevation. The siding on the exterior of the barn is tongue-and-groove on the west, vertical on the east, and new board siding on the north. The roof is standing seam metal. The interior was inaccessible. Attached to the north end of the barn is a concrete block loafing shed which does not contribute to the significance of the complex due to recent construction.

Bank born, north elevation

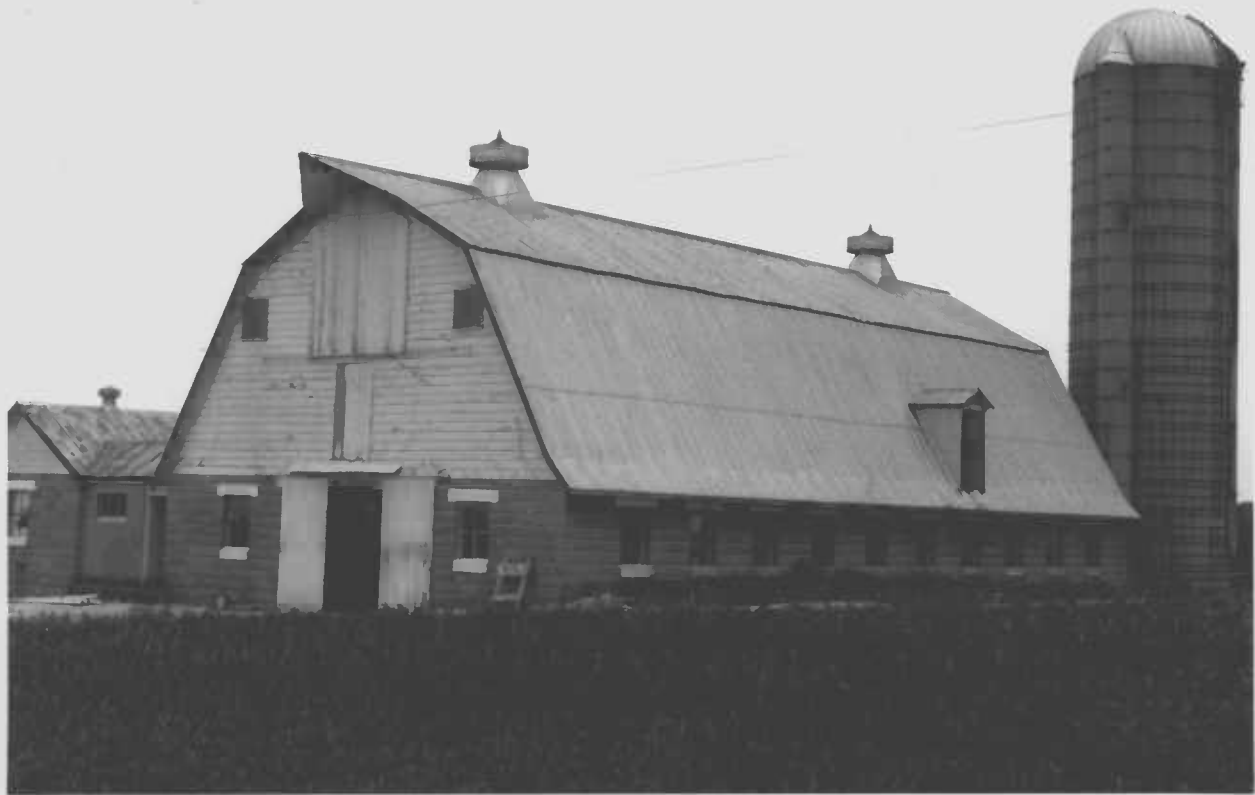
7/7

Dairy barn: The circa 1940 dairy barn is located west of the bank barn and is a concrete block structure with frame gables and a gambrel standing seam roof. The concrete blocks are rusticated and the siding in the gables is german. The barn's milking aisles are oriented on a north-south axis.

Dairy barn, north elevation
